Baltic and beyond Change and continuity in shipbuilding

Proceedings of the Fourteenth
International Symposium
on Boat and Ship Archaeology
Gdańsk 2015

41. The 'Baidak' Vessel from the Desna River

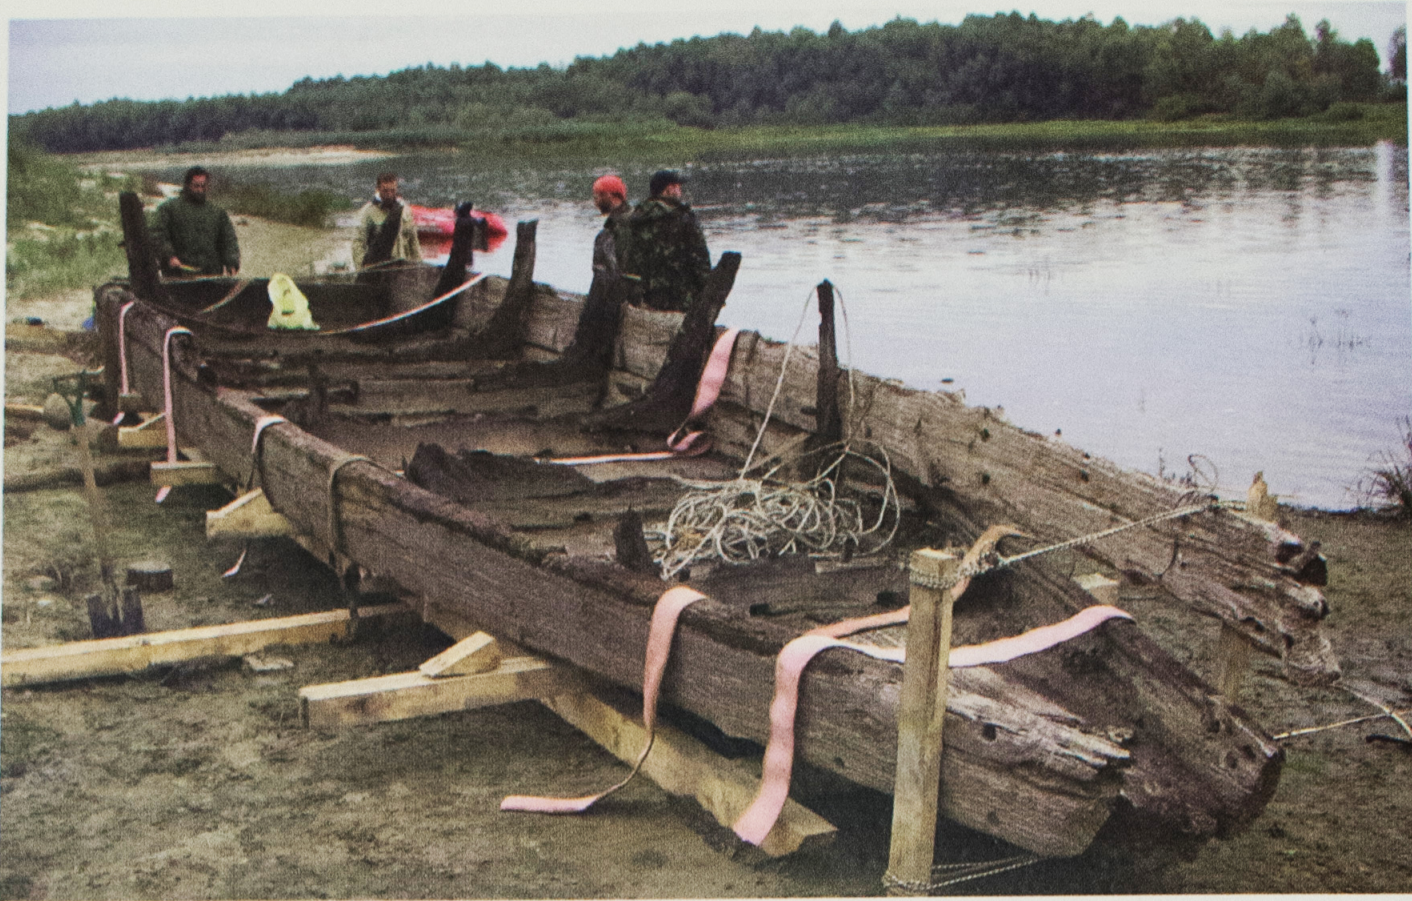
The *baidak* hull was not preserved intact. On both sides the third upper planking strake was missing, and only half of the second strake on the starboard was preserved on the side of the stern. The planking edge bore new traces of an axe. The vessel stem was missing. As a result, the medium strake along the portside had become unbent. Besides, the lower strake had a crack near its end. There was also bad damage to the starboard futtocks. The second and the third one were missing. Some wooden pins were also missing. During two months ashore the hull dried and deformed. The wood was covered with longitudinal and transverse hairline cracks. Most of the futtocks on the portside were deformed (Fig. 1).

Figure 1: Preparation for crossing the vessel through Desna river

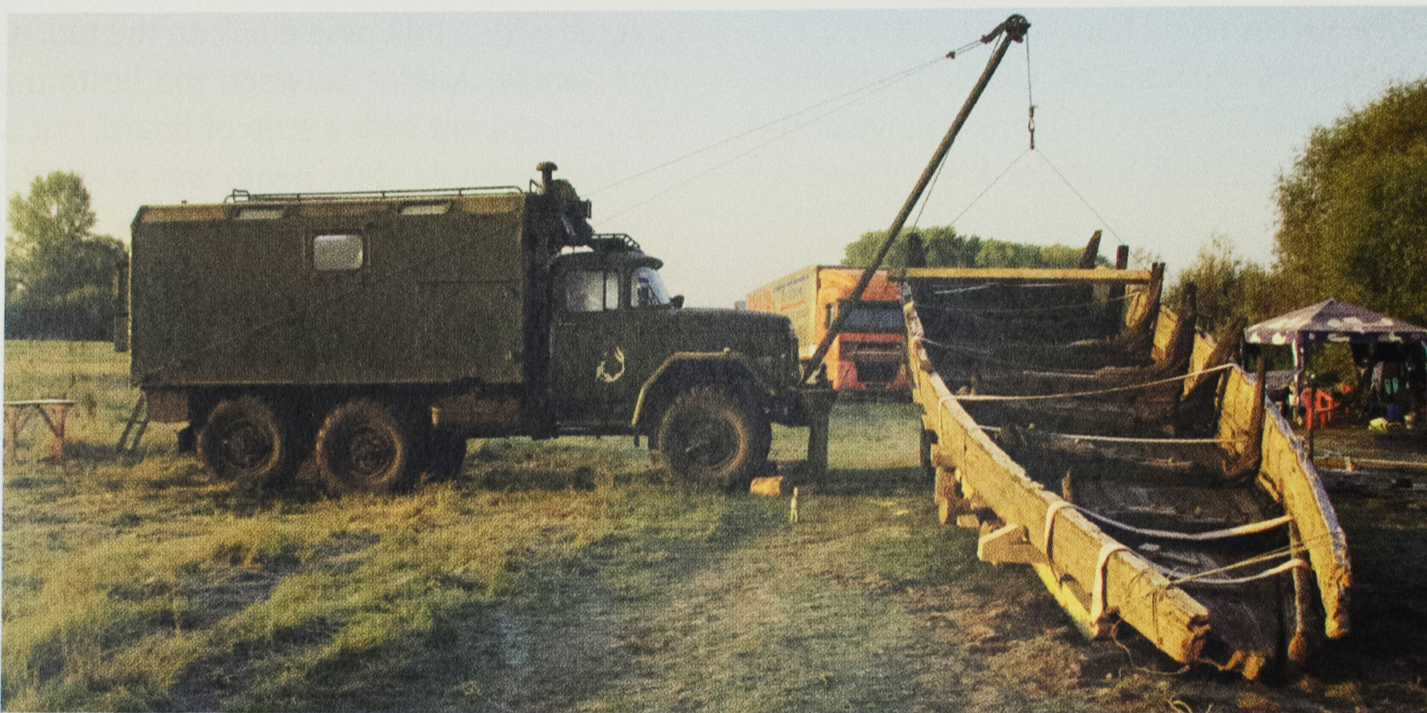
According to recollections of a local resident P. Kachkan, such vessels were used on the Desna up to the 1970s for cargo transportation. Each village had one or two such boats. Its condition enabled restoration and turning it into one of the central exhibits of a future maritime museum on the Dnieper. It should be noted that the vessel design maintained traditional features typical for European river shipbuilding of the 17th–19th centuries. During second trip to the Desna in October 2010 the wreck was transported to Zaporozhye (Fig. 2) (Kobaliia and Denysenko, 2015: p. 64).

Figure 2: Loading a baidak on the trailer

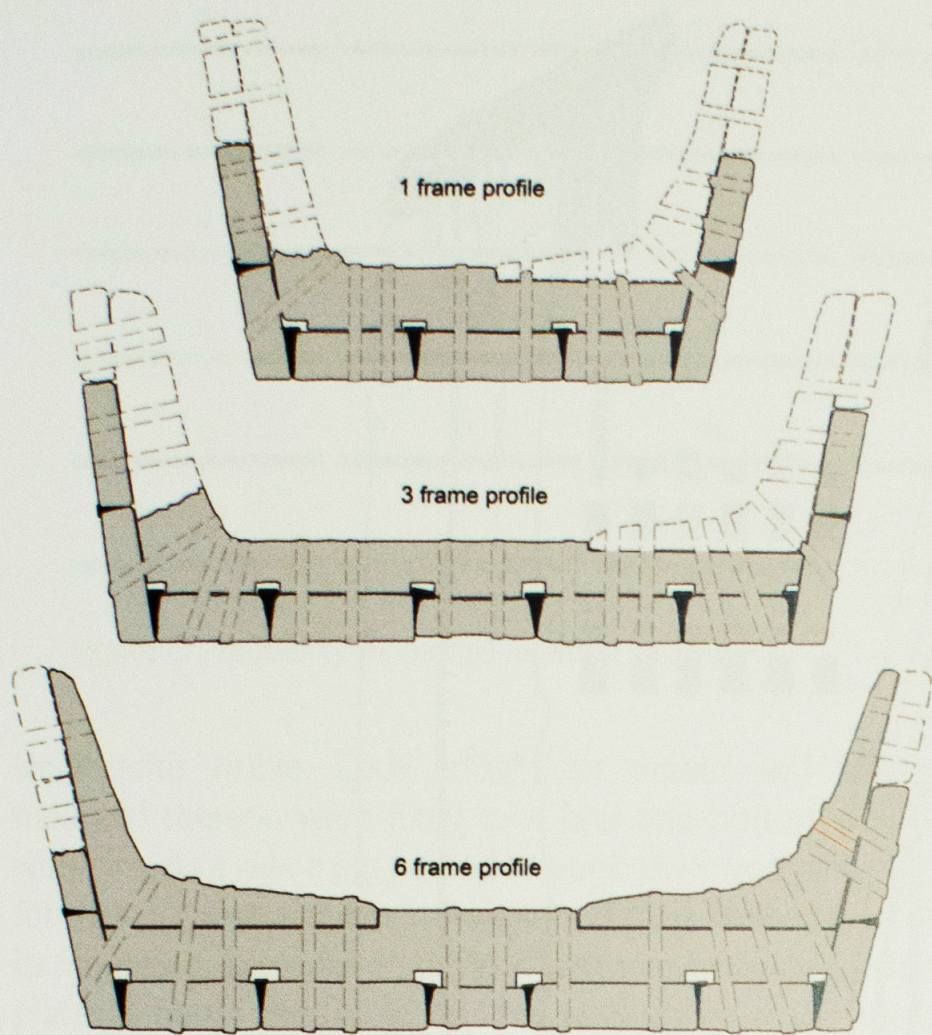
An athwart set included floors and so-called *botias* mounted above in special incuts. The boat has totally seven athwart sections somewhat different in design. In its narrow part the framing is made of oak. The first three prow sections were made of the whole timber with a part of a tree branch shaped as a frame joining the strakes. Each frame had a rounded inner side and a flat outer side. On the other side the section top surface had an incut to receive oak *botias* similar to the opposite side. Section 4 and the following ones were made in a different way. The floor here was made of a normal square pine beam with grooves on the top at the sides. These grooves on both sides had already received two oak *botias* each. The last seventh section was located not on the inner, but on the outer side of the transom. The floor is made of pine. The right-hand *botia* is preserved in its bottom part. The left-hand one is preserved completely. The *botias* at the stern differ from the others with availability of additional pins that join them not only with the side and bottom planking but also with the transom (Fig. 3).

Figure 3: The frame profiles

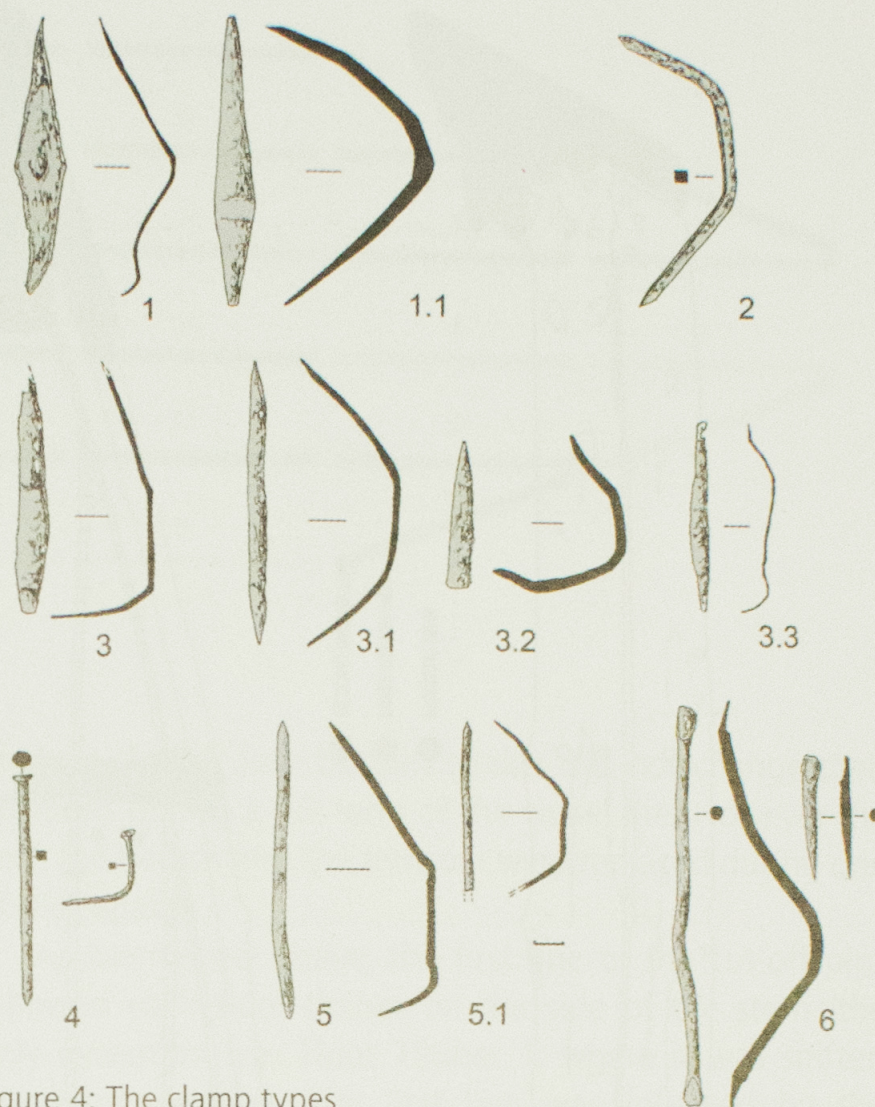
The principal fasteners of the pine planks were flattened forged clamps, and the secondary ones were forged. All in all there were 6 clamp types and subtypes (Fig. 4).

Figure 4: The clamp types

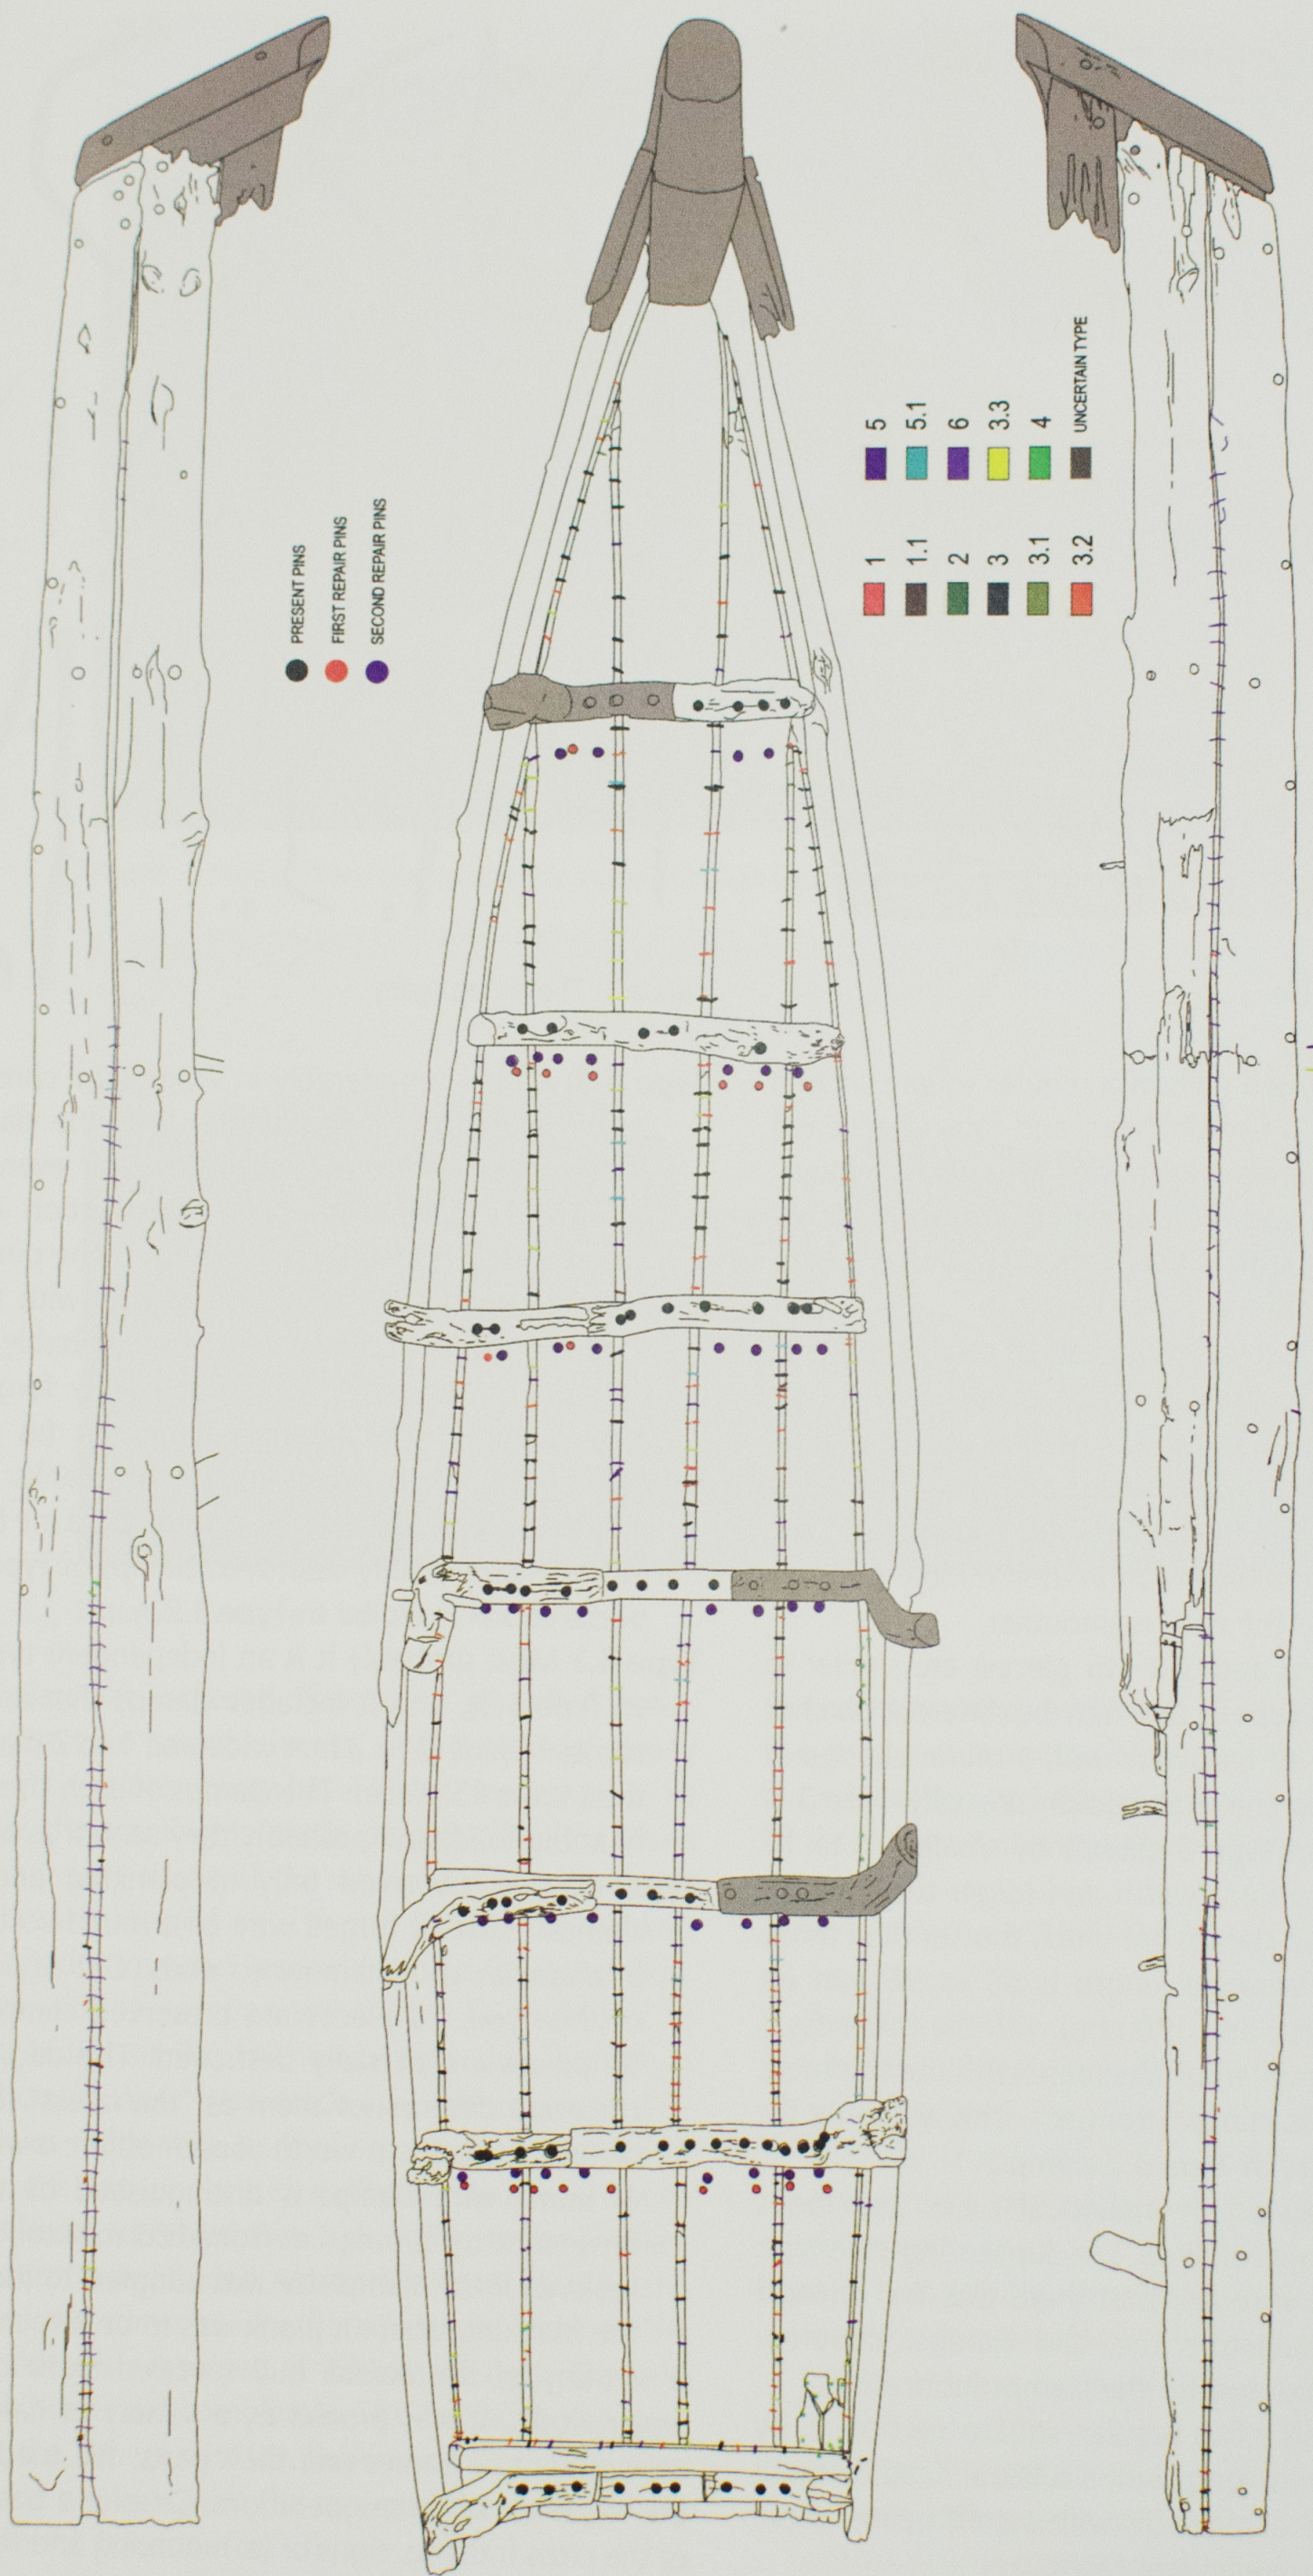
Figure 5: Types of pins and clamps

Just after bringing the artefact to the restoration site we saw that near each floor timber there were lines of pins that had been nailed earlier. However, the number of lines varied (Fig. 5). At the first floor timber there were two lines, one of them under the preserved timber, while the second one was shifted towards the stern. The second floor timber had three lines, one of them functional and two other antecedent, Floor Timbers 3 to 5 also had two lines each, while Floor Timber 6 had three lines. Non-functional antecedent lines were preserved in a form of holes closed with pins that were cut flush with planks. Just as with the first timber, all re-nailing lines were shifted towards the *baidak* stern. Evidently, in the course of repair antecedent pins were not removed, but cut off directly under a timber so that it could be separated from the bottom. The only place that bore no evidence of the former nailing was the last timber (#7) at the transom.

All this points to two major repairs of the hull followed by frames and planking replacement. The further examination determined that the pin diameter in nearby parallel lines varied. Also, the pattern of their cutting-off differed. In the line next to the preserved timber the pins were of a larger diameter and as a rule were cut off evenly. In the next line the pins were of a smaller diameter with ragged edges that sometimes projected above the surface. That difference in a pattern of the hardware fixing and replacement was rather useful, as it gave us an opportunity to retrace a succession and nature of repair procedures.

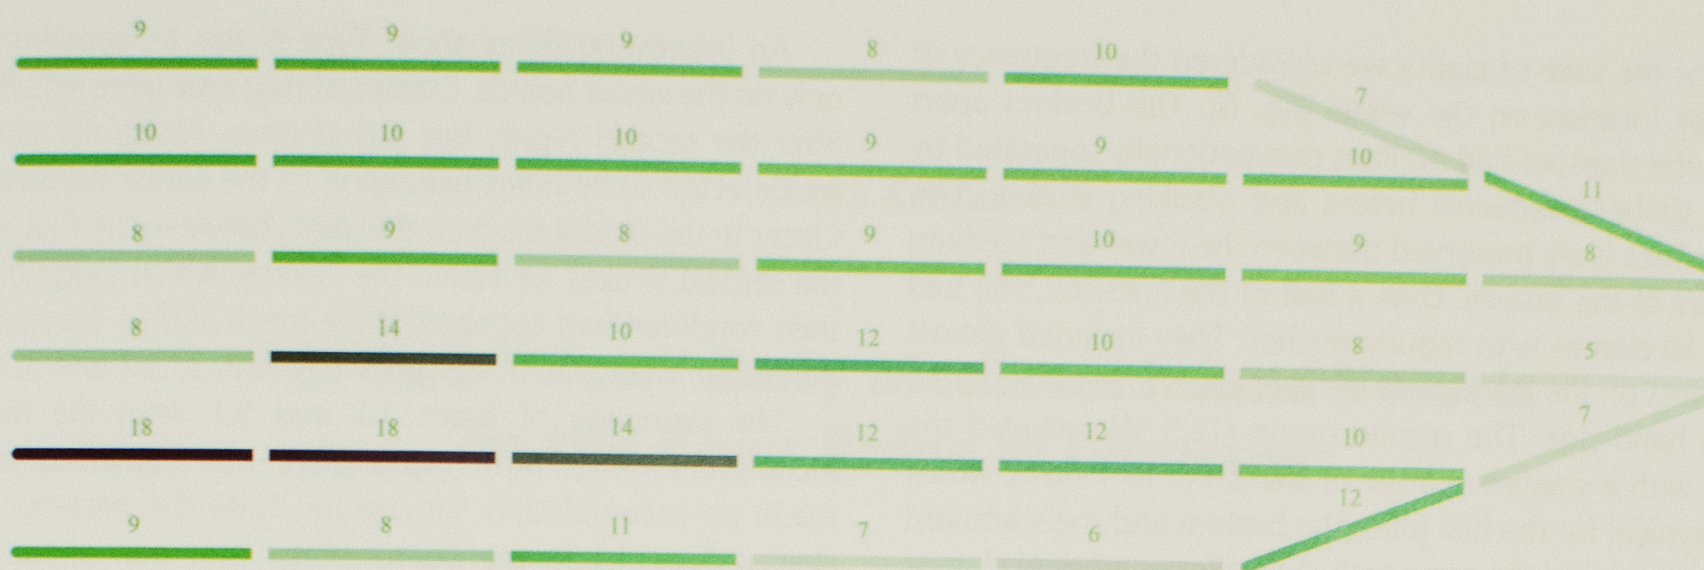
Figure 6: Frequency of clamps location on vessel

For the sake of clarity we considered the frequency of clamps location on the vessel (fig. 6). The bottom apart from the transom had 40 lines conventionally separated by floor timber transverse beams and planking strakes. Two more lines were preserved between the lower and medium strakes of the boards. Over a half of the lines (62.5%) had 8 to 10 clamps with regular pitches. They included almost all joints on the left side of the keel and some joints on the right hand side. The second group (12.5 %) included the lines with a smaller number of clamps (5 to 7 nos.), which was typical for the first joint (the bottom and the starboard joint place) and the prow area. A smaller number of clamps apparently could be explained by losses due to the hull destruction, i.e. the board separation from the bottom and the loss of the stem. Points of rupture with apparently lost clamps added up to this suggestion. Most probably here as well as in the first group the original number of clamps had to be 8 to 10. The remaining part of the lines had a larger number of clamps (11 to 18 in number.). Most of them were located in the third, and even more so in the second line on the portside. The number of clamps in the second line permanently increased towards the stern. Thus we record the evidence of repair in the second and the third joints closer to the stern. In other cases, a repair, if any, was of a local nature. Let us consider this issue in more detail.
